# Site 1026<sup>1</sup>

Expedition 301 Scientists<sup>2</sup>

Three Circulation Obviation Retrofit Kit (CORK) borehole observatories were installed during Expedition 301 in Holes 1026B, U1301A, and U1301B. The first of these systems replaced a CORK observatory deployed during an earlier expedition; the second and third are in newly drilled and cased holes. The new Hole 1026B CORK system was the simplest of the systems deployed during Expedition 301. It comprised a CORK-II body with 4½ inch casing extending to 201.5 meters below seafloor (mbsf) and a single packer element set in casing near the bottom of the 4½ inch casing. No 4½ inch casing was installed below the packer element sub because the hole was completely cased at depth, and there was no need to provide additional protection for the instruments hanging below the bottom plug.

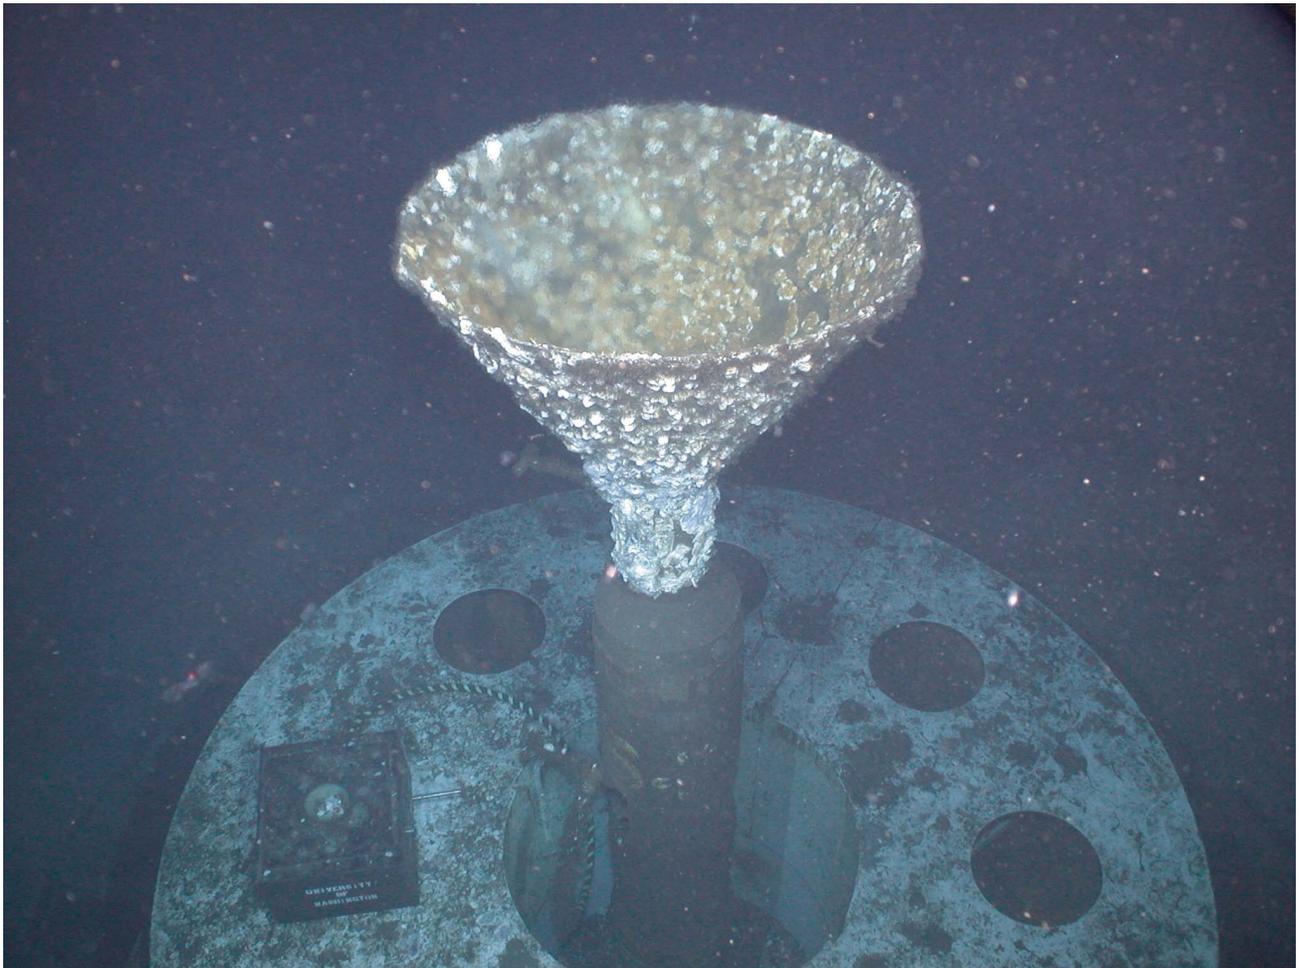
**Figure F1.** Photograph of Hole 1026B CORK installed during Leg 168. An ~1 m diameter minicone (white cone-shaped object on top) was placed by submersible on top of the CORK head (brown vertical tubular shape in middle) to facilitate wireline reentry during nondrillship operations. This minicone had to be removed prior to retrieving the CORK and ROV platform (large, flat circular object surrounding the CORK head).

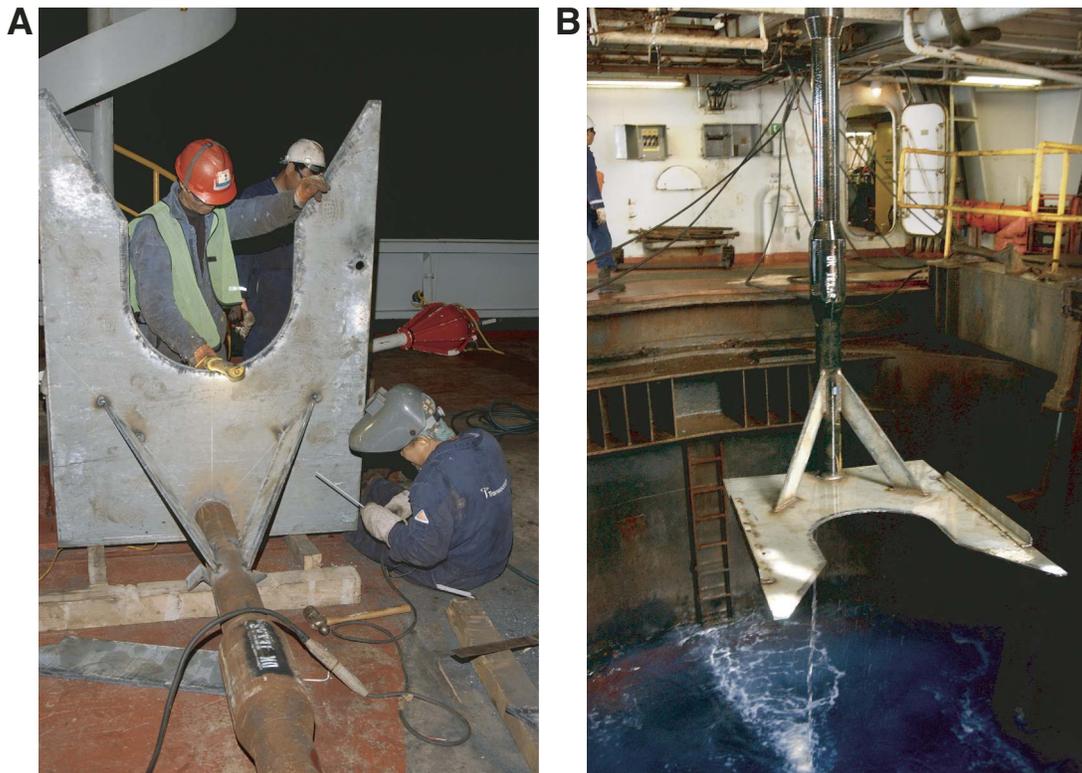
**Figure F2.** Fork-shaped fishing tool fabricated to remove the minicone in Hole 1026B. **A.** Construction of fishing tool. **B.** Deployment of fishing tool through the moonpool.

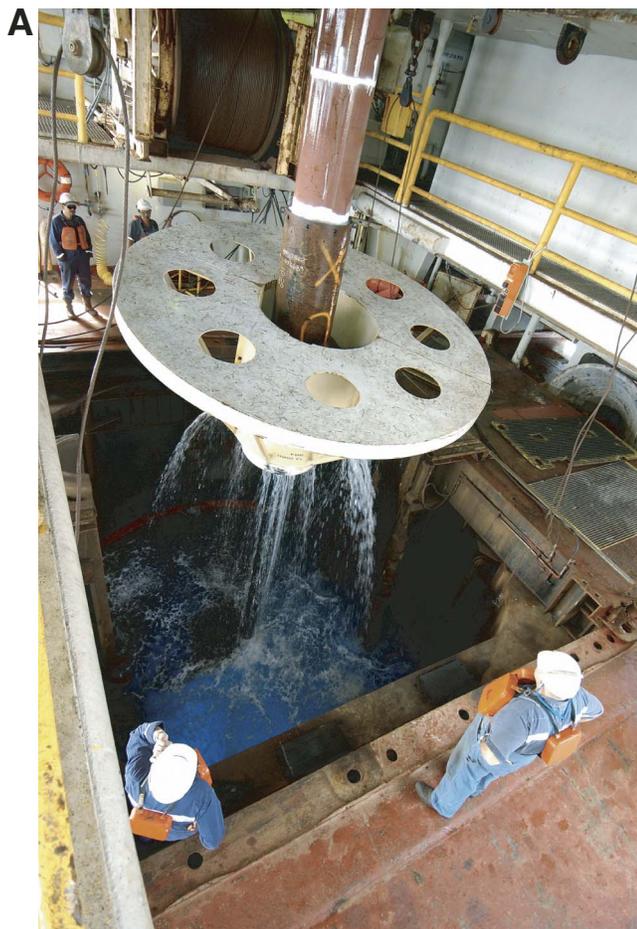
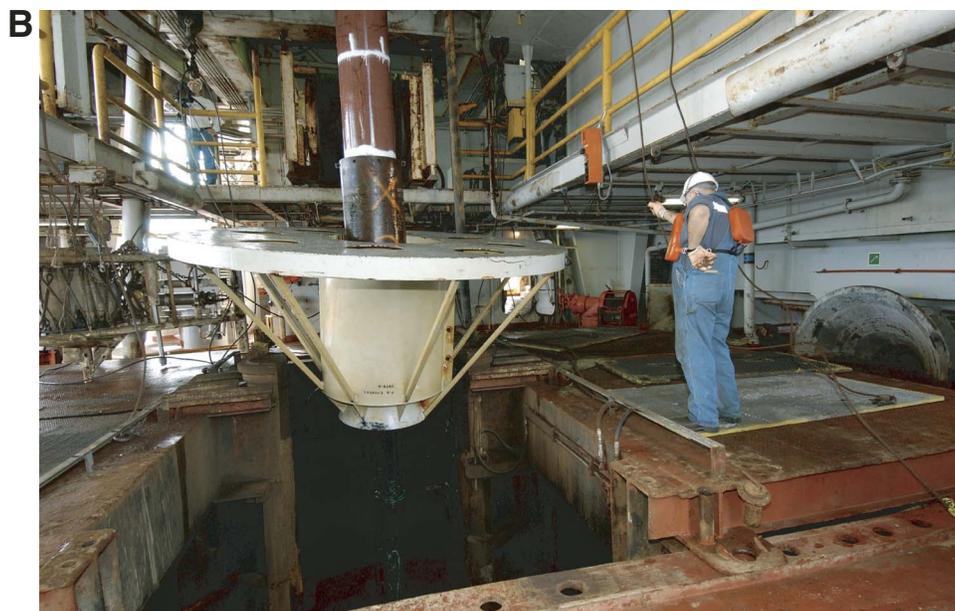
**Figure F3. A, B.** Retrieval of the old Hole 1026B CORK and ROV platform through the moonpool. It was originally installed during Leg 168. The brown pipe above the ROV platform is the CORK pulling tool, which has the old CORK head latched inside.

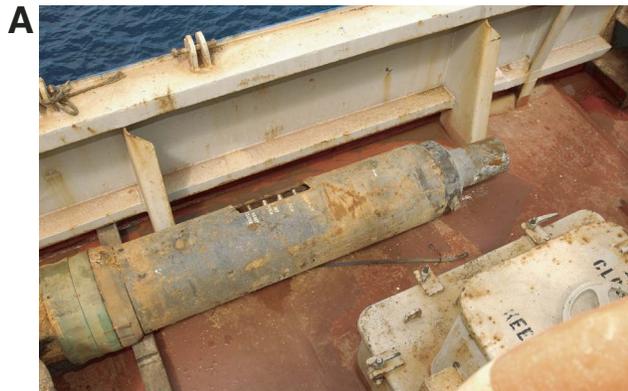
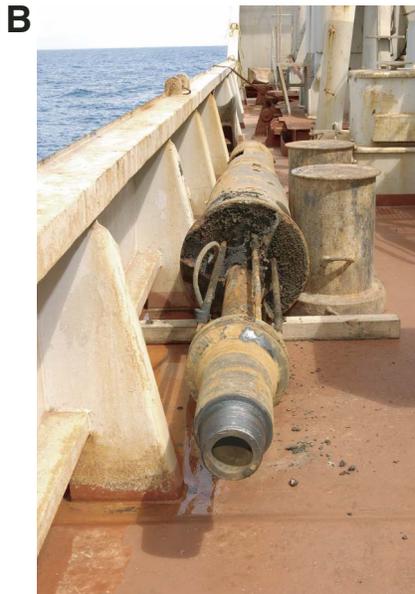
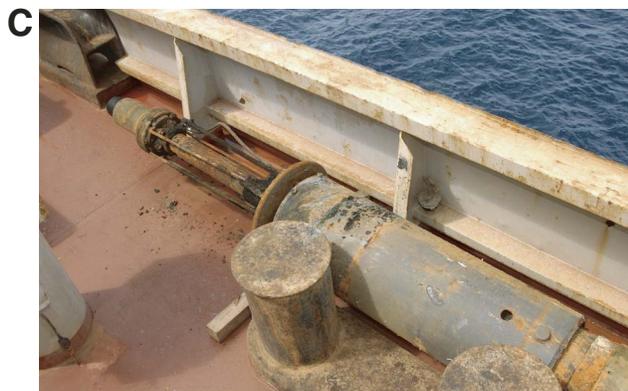
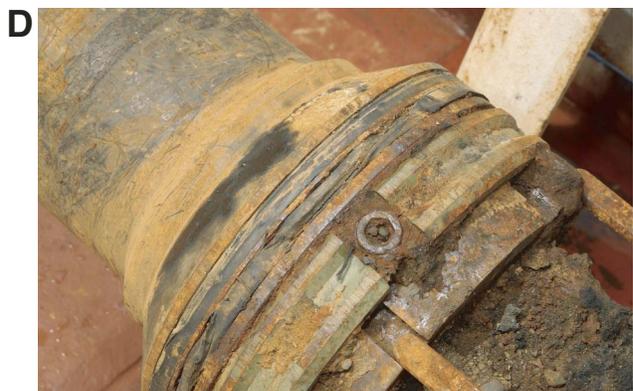
**Figure F4.** The old ODP Leg 168 CORK body on deck shortly after retrieval. **A.** Upper half of CORK head with sampling/monitoring port access. **B.** Lower part of CORK head. **C.** Lower half of CORK head. **D.** Borehole seal. The lower right portion was exposed at above the seafloor; the upper left was sealed in the borehole.

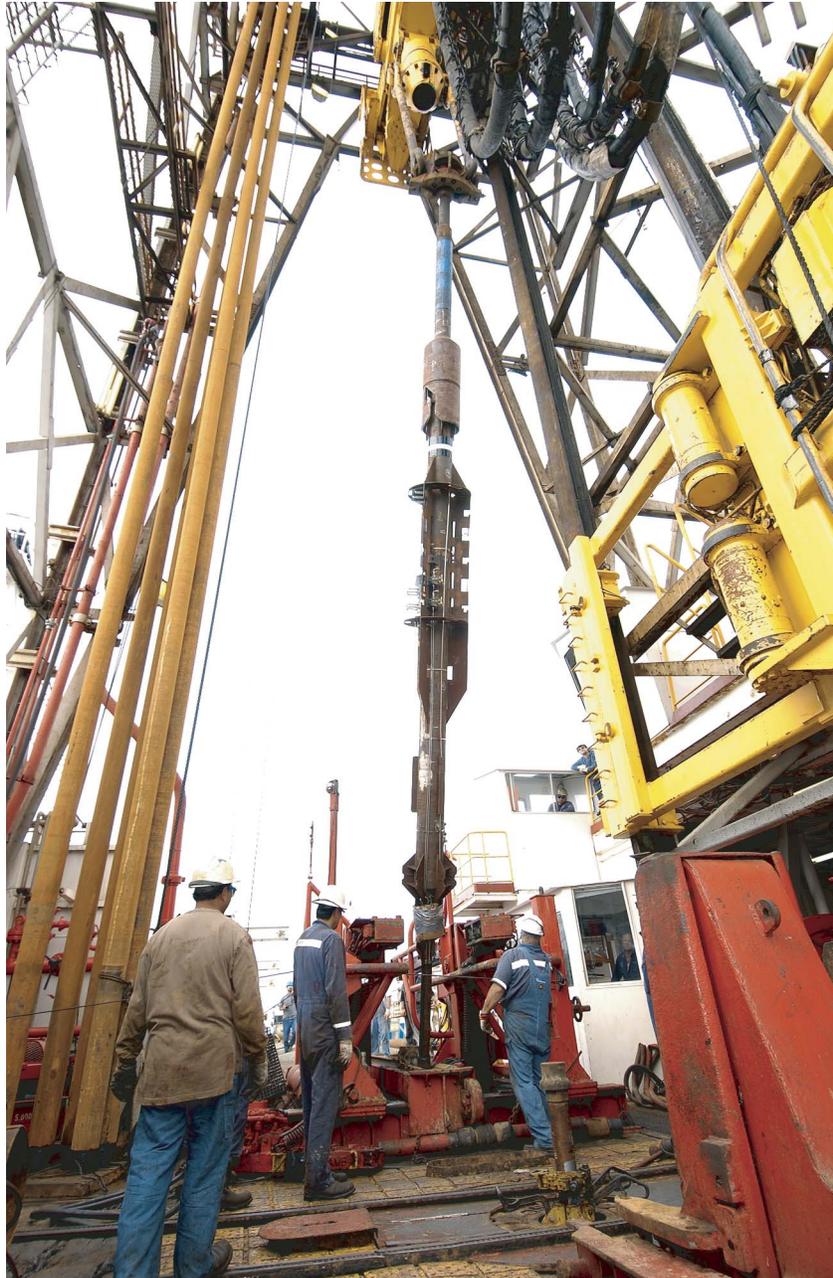
Figure F5. The Hole 1026B CORK-II head being lifted into the derrick using the CORK running tool.

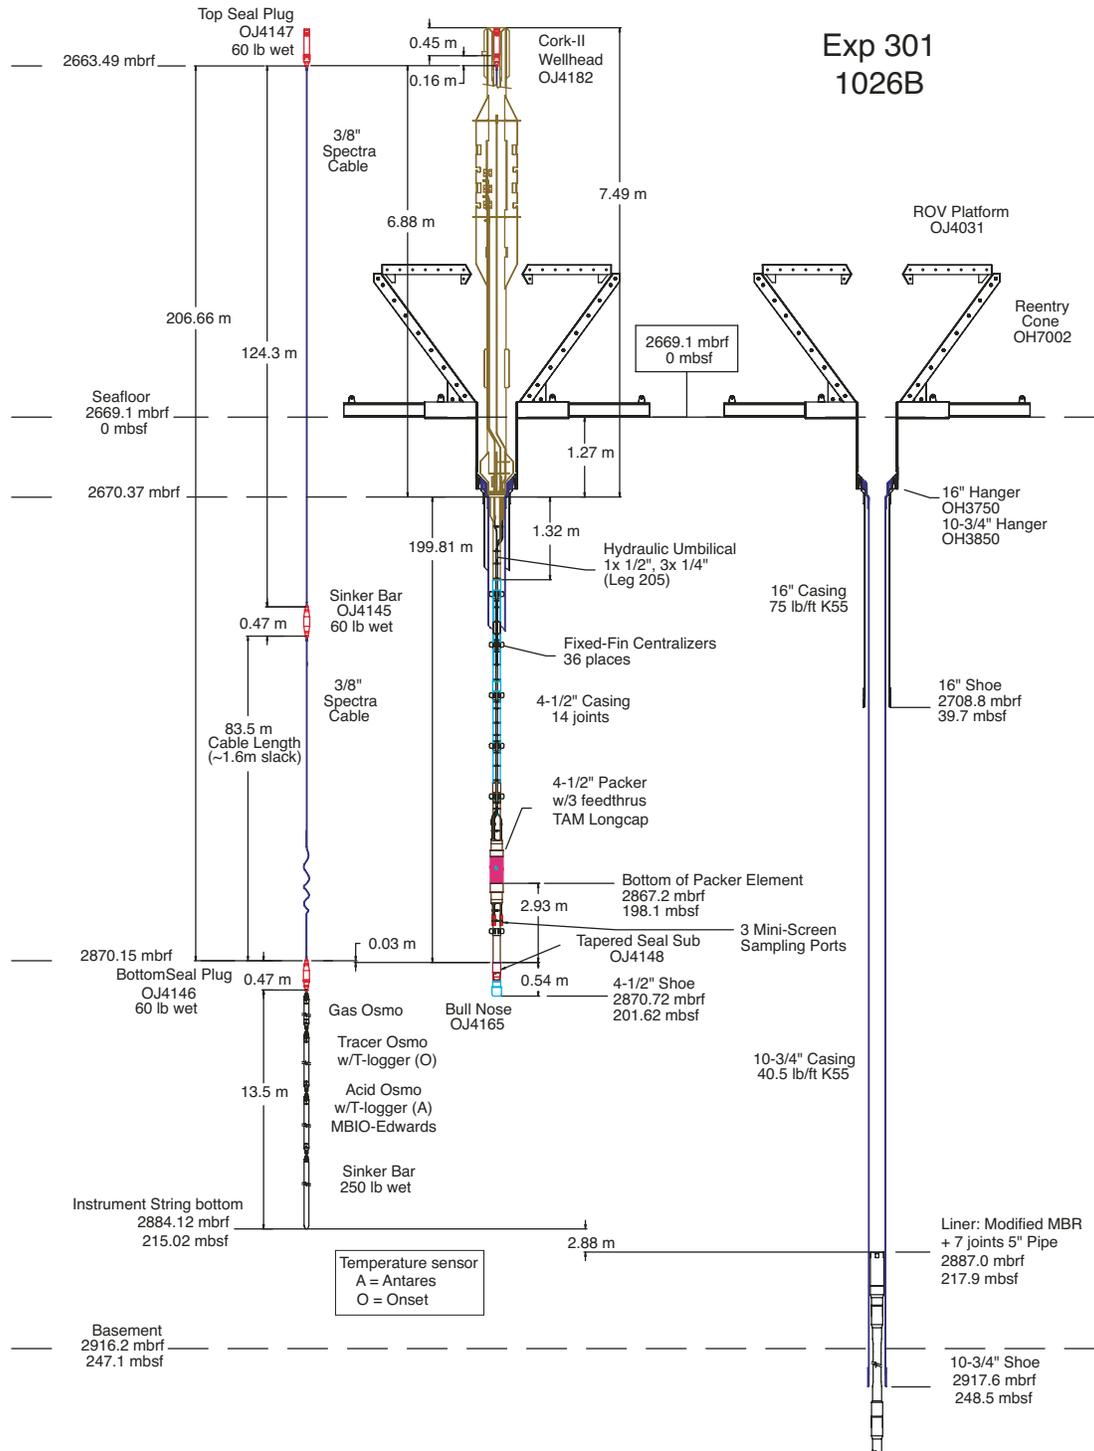
**Figure F6.** Schematic showing the Hole 1026B reentry cone and borehole casing (right), CORK-II borehole completion (center), and the instrument string deployed through the 4½ inch casing of the CORK-II (left). ROV = remotely operated vehicle. MBR = mechanical bit release. MBIO = microbiology sample. TAM = TAM International.

At 1500 h on 3 August, we prepared to assemble the new CORK-II. A 4½ inch casing packer was made up to a casing seal sub. We lowered it to the moonpool where we attached three miniscreens just below the bottom of the packer. The lower end of the umbilical (leftover from Ocean Drilling Program [ODP] Leg 205) was attached to the top of the packer, and we attached 14 joints (189.95 m) of 4½ inch casing. The umbilical was strapped to the casing using plastic tie wraps and stainless steel banding. Thirty-six rigid casing centralizers were attached to the casing to protect the umbilical during deployment. We attached the CORK-II running tool to the top of the CORK-II head (Fig. F5), secured the head to the top of the 4½ inch casing string, and lowered it into the moonpool to make the final umbilical connections at the bottom of the head. Figure F6 shows the CORK-II assembly.

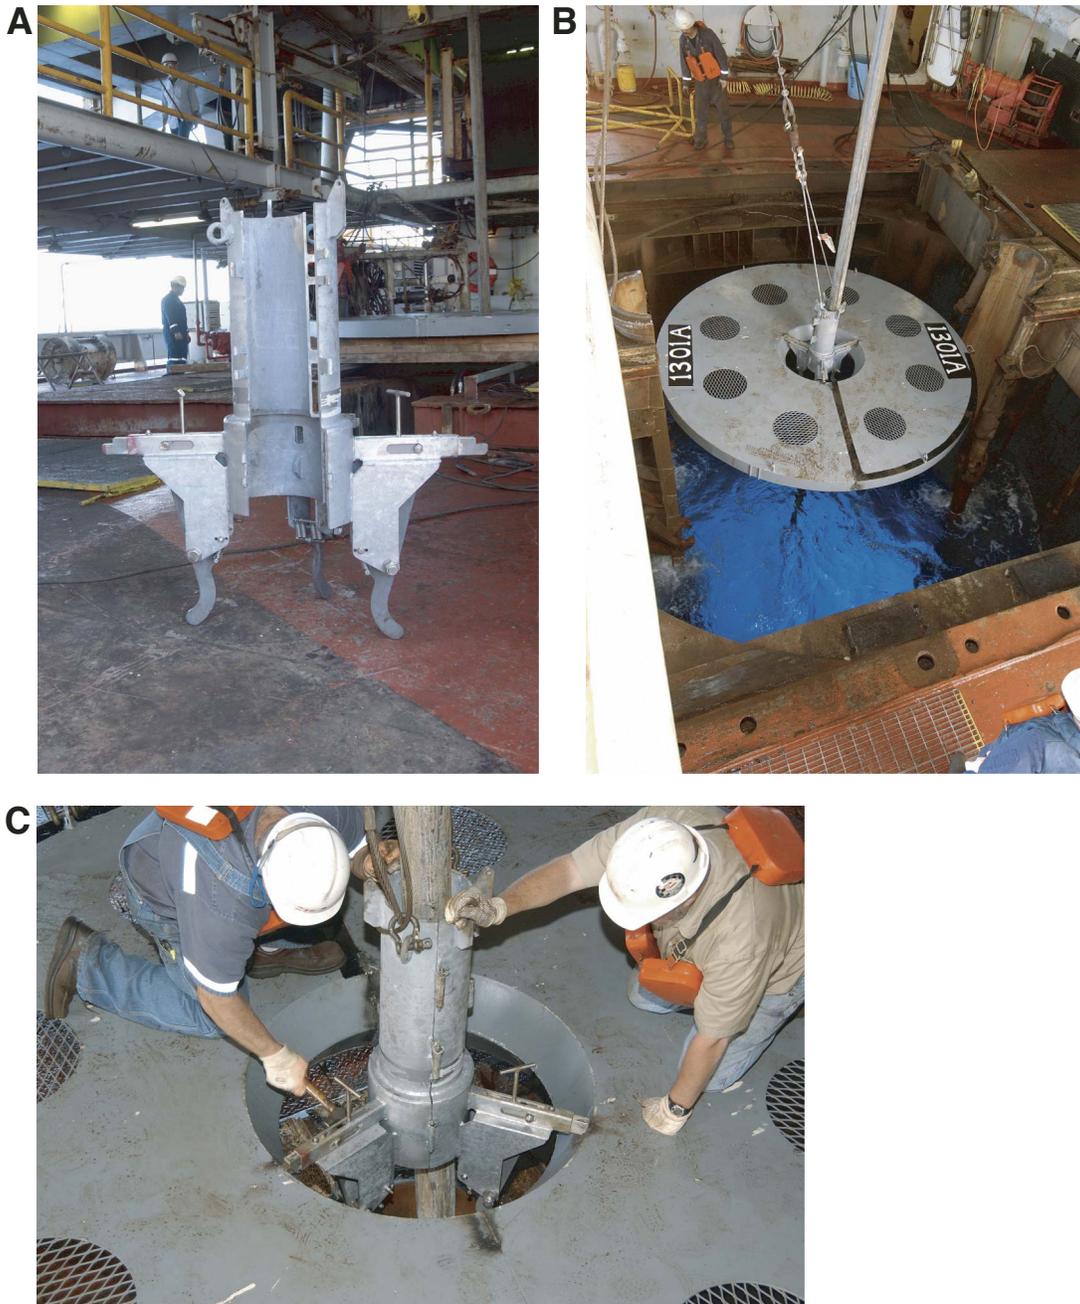
**Figure F7.** The wireline-conveyed mechanical deployment tool (Lula). **A.** Lula shown in its open position before being placed around the drill string. When the legs on the bottom touch down on the top of the CORK head, the ROV platform is released. **B.** The logging wireline is attached to the top of the Lula and is used to lower the entire assembly to the seafloor. **C.** Lula being latched into the center of the ROV platform.

The platform was successfully released without any of the difficulties we experienced when deploying the platform in Hole U1301A; repairs and modification to Lula prior to Site 1026 operation and modified deployment procedures were successful. We recovered Lula at 1015 h on 5 August. We then deployed the camera/sonar system to inspect the platform and CORK-II and to observe the release of the CORK-II running tool. When the camera reached the seafloor, we observed that the platform had not landed properly. One side of the platform hung up on the plate at the base of upper set of gussets on the CORK-II head during the free fall. After reviewing the engineering drawings of the CORK-II head and platform, it became clear that in some orientations it is possible for the platform to hang up on the CORK-II head. This can easily be prevented by installing three additional vertical gussets to the top of the CORK-II head. We modified the remaining CORK-II head assemblies.

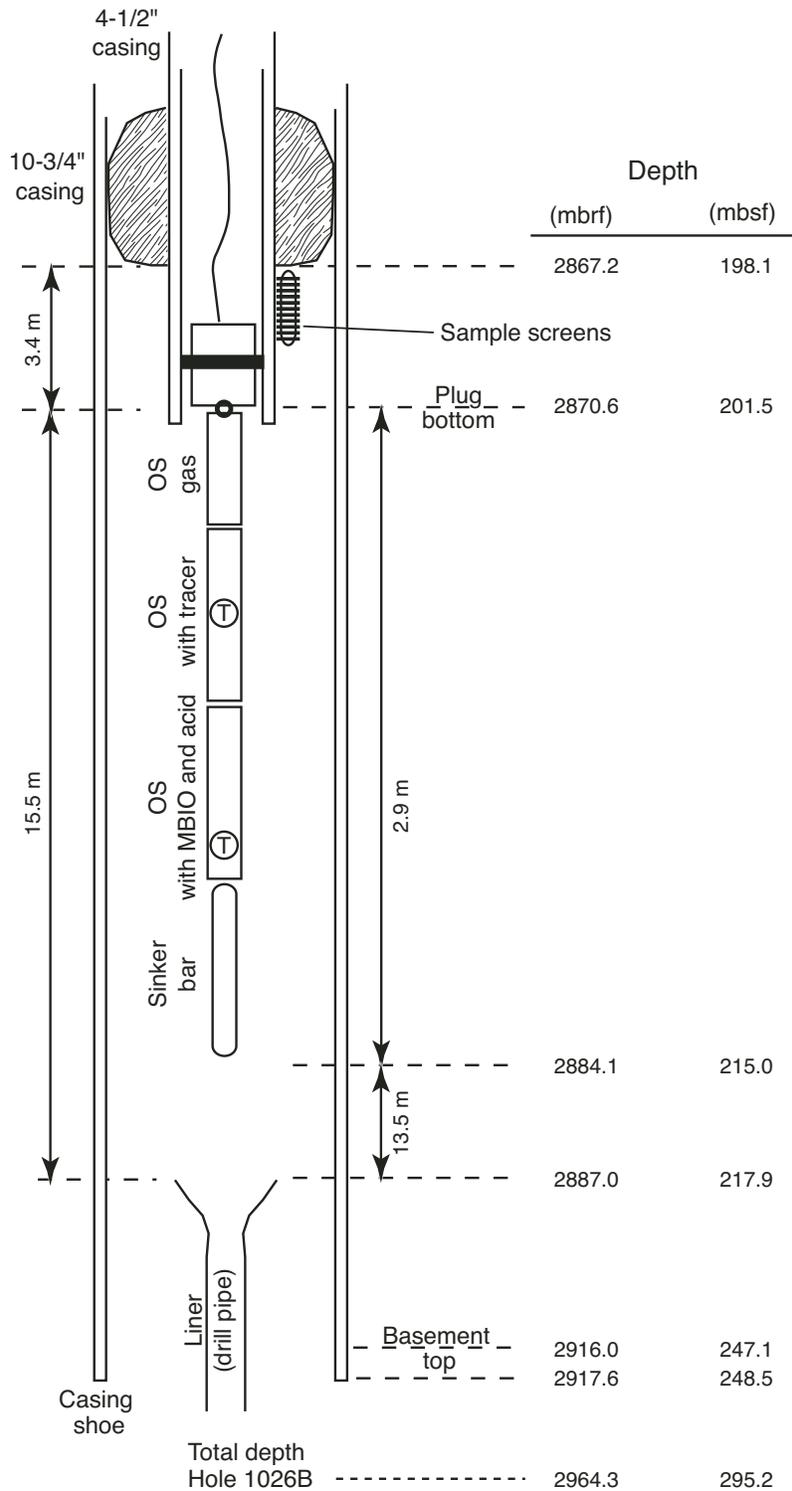
**Figure F8.** Drawing showing observatory completion at depth in Hole 1026B. Positions and geometries of OsmoSampplers (OS), temperature loggers (T), and intake screens are highly idealized. Please see drawings of complete CORK system in Figure F6 and in Fisher et al. (this volume). MBIO = microbiology sample.
